BIONIQ CLINICAL CASEBOOK

MUDr. Jaroslav Tvrdik	
Functional for 23 years: 3.7 mm diameter implant after a front tooth injury	42
MUDr. Jaroslav Tvrdik

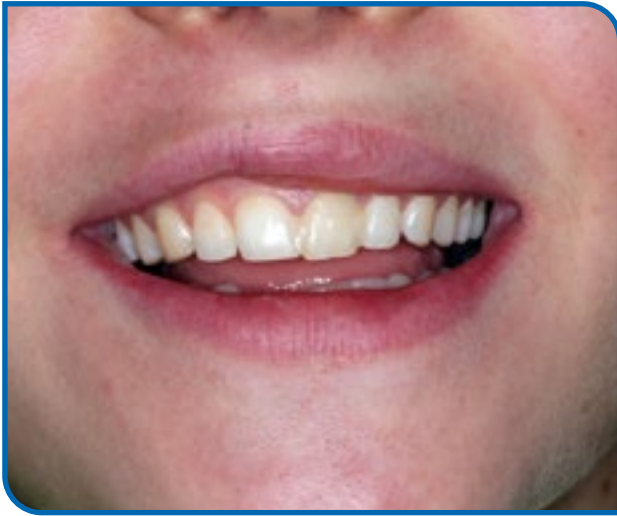
2 A chronic fistula in region 21. The blocked tooth 21 with a different discoloration. The intraoral radiograph 21 confirmed incomplete endodontic treatment and partial root resorption.

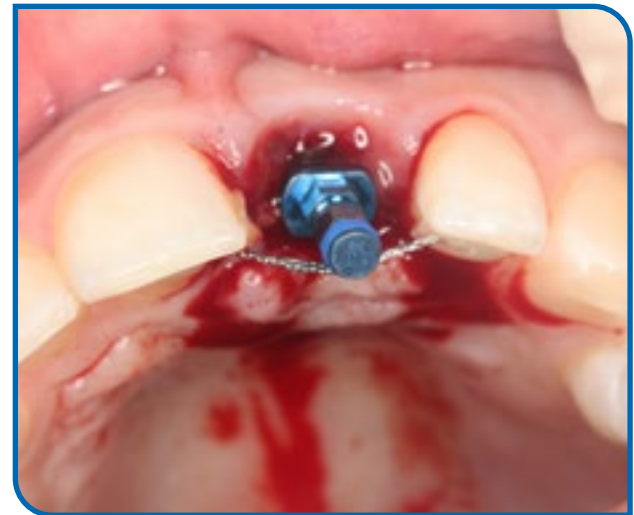
8 The mucoperiosteal flap was lifted palatally and partially mobilized vestibularly. A 14 mm long [BioniQ implant](#) from LASAK with Ø 4 mm was inserted and a temporary abutment was attached after removing the implant carrier.

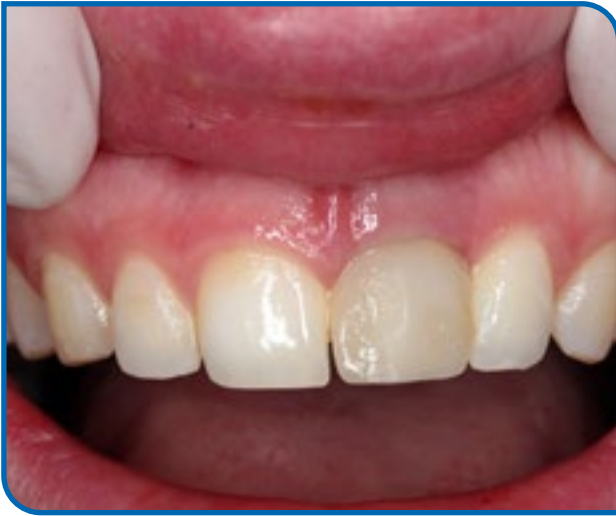
10 Four months after implant placement and immediate loading, the temporary crown was removed. An all-ceramic crown was fabricated in the laboratory.

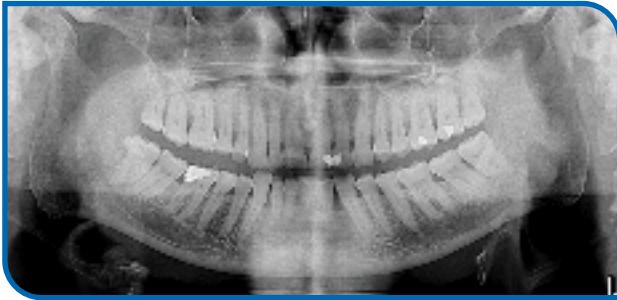
2 The two-root tooth was carefully extracted. A 10 mm long, Ø 4 mm [BioniQ implant](#) was then inserted in the space of the former right root. The vestibular part was augmented using [OssaBase-HA](#).

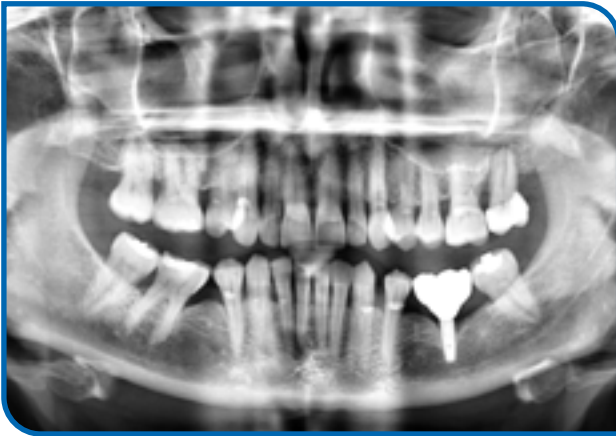
2 CBCT scan three months after implant removal.

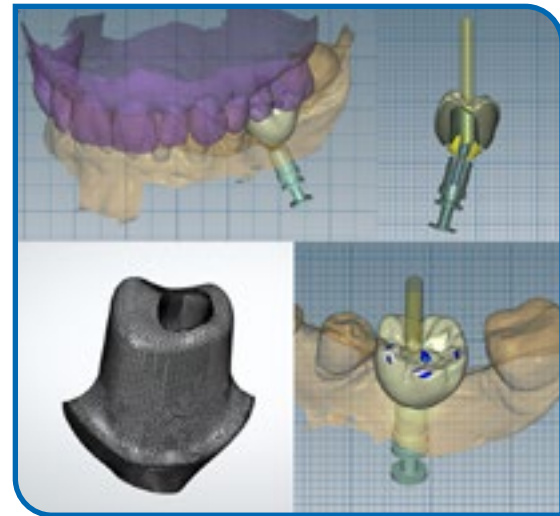
8 Design of the individual abutment and the dental crown in the exocad program. An individual abutment with an angled screw channel was planned for better access to the restoration.

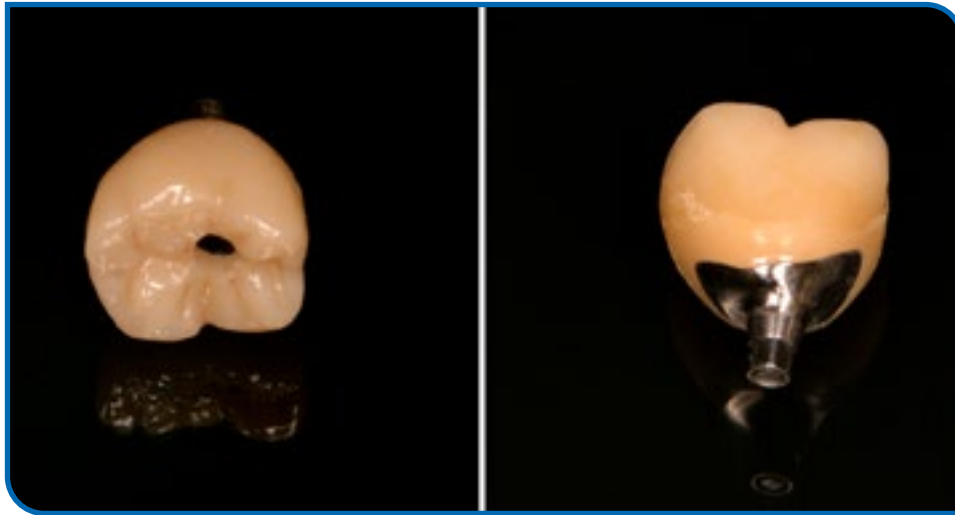
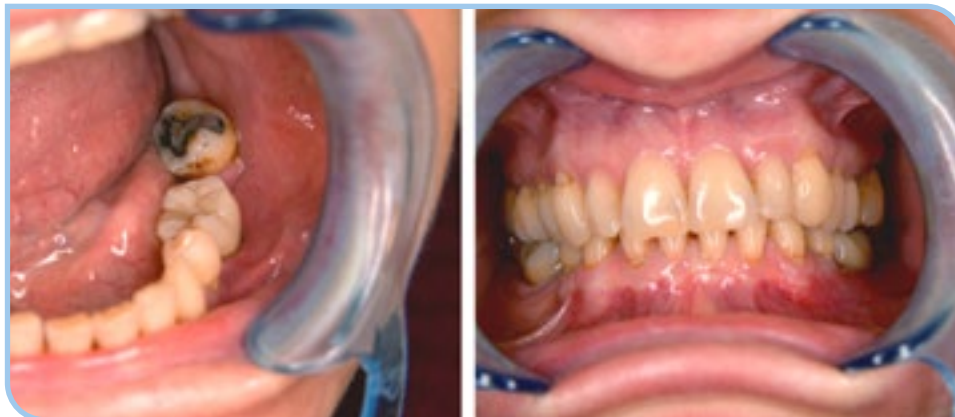
- 10 The final result after placing the dental crown at the site of tooth 36.

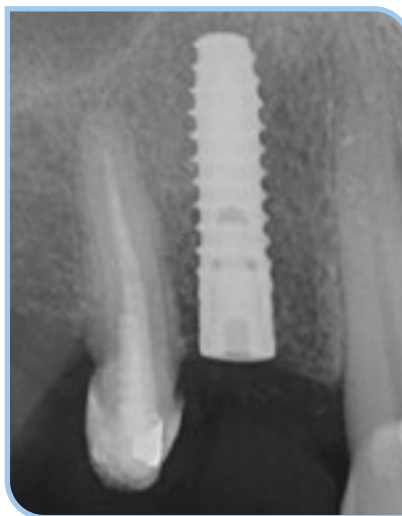
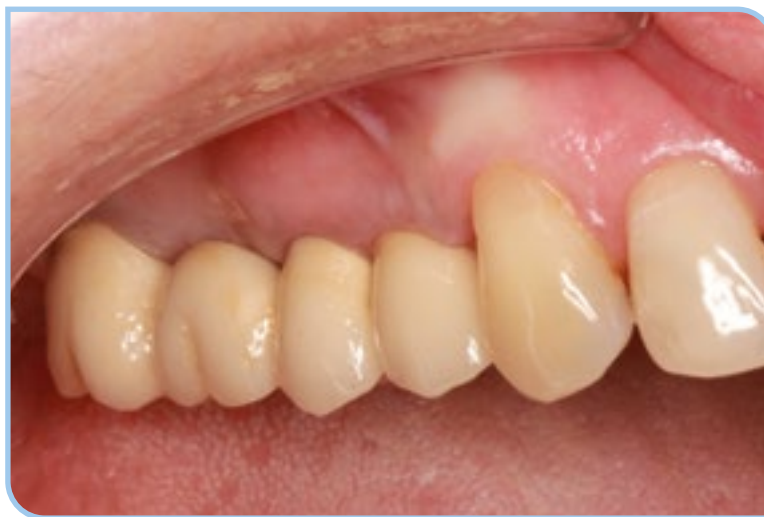
8 The final result after placing a fixed dental bridge on teeth 17-15 and an implant-supported dental crown on tooth 14.

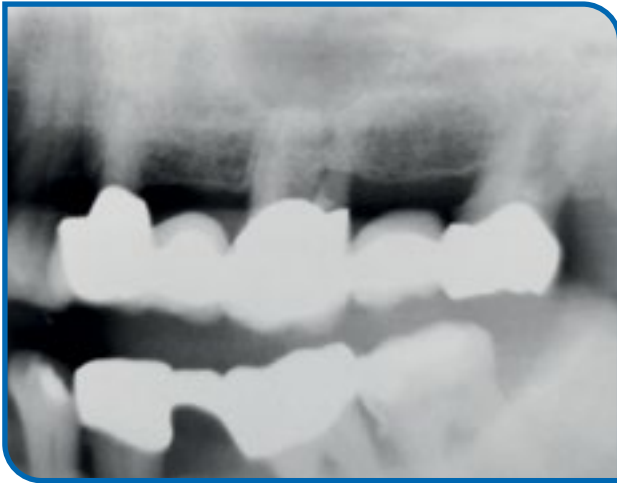
2 After healing, two 12 mm long [BioniQ Plus implants](#) with a 3.5 mm diameter and 1.7 mm high machined neck were inserted and the area was simultaneously augmented with autologous bone and [PORESORB-TCP](#). The augmented area was covered with a collagen membrane ([Collagene AT[®]](#)).

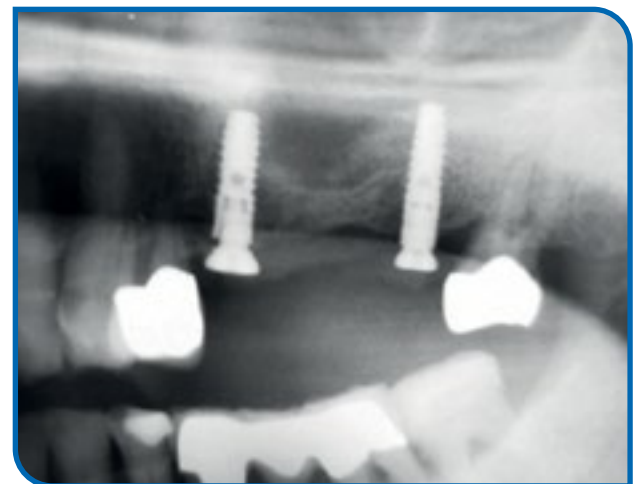
4 Postoperative control radiograph: the gingiva former at 24 still needs to be retightened.

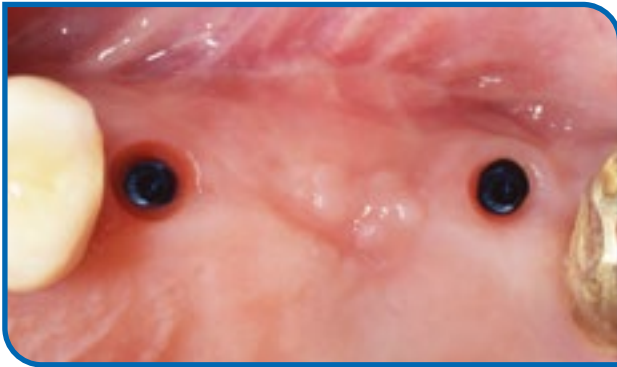
6 The ISQ value determined after exposure was 74 ISQ on both [BioniQ Plus implants](#).

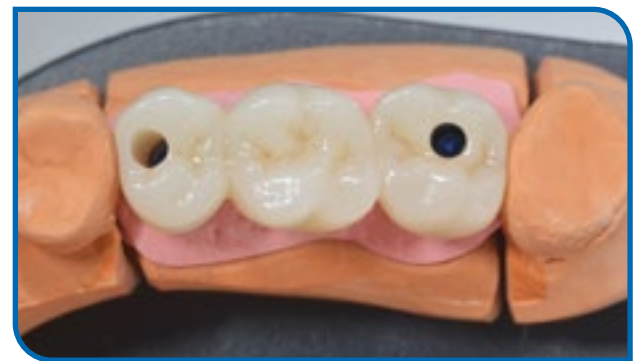
8 The dental technician decided to complete the prosthetics "in one session". The model situation with a zirconium oxide bridge placed on the prefabricated abutments.

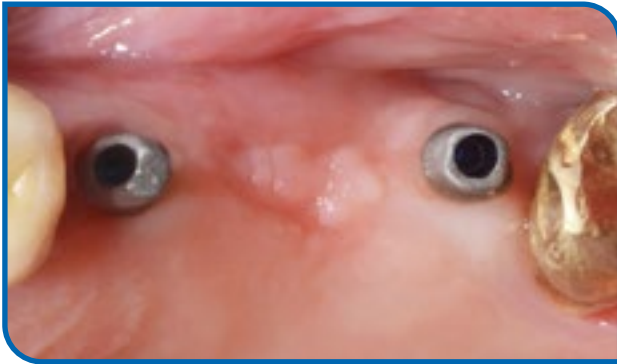
10 Excellent fit and functional as well as highly esthetic result. The final prosthesis was placed five months after implant placement. The occlusal screw openings were "service-friendly" sealed with composite.

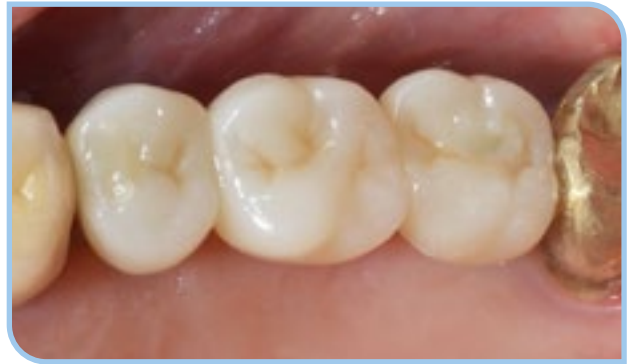
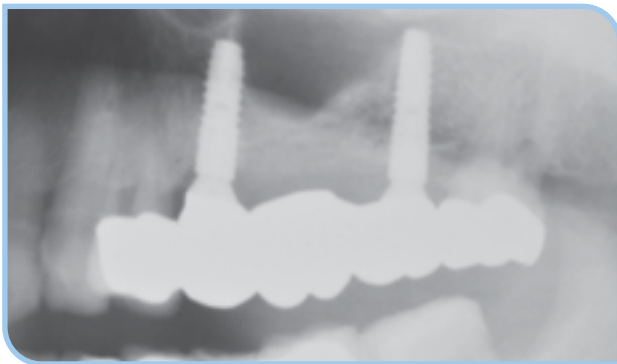
11 X-ray control image 23 months after implantation.

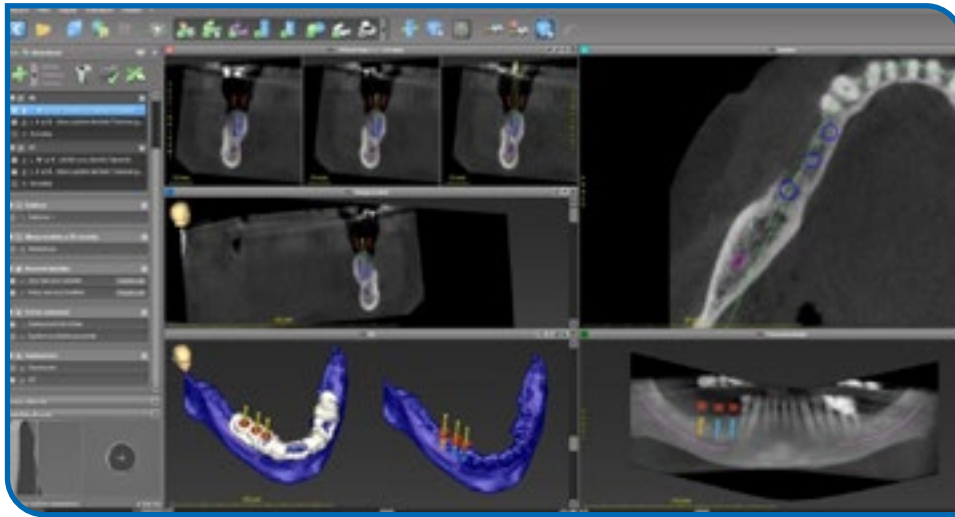
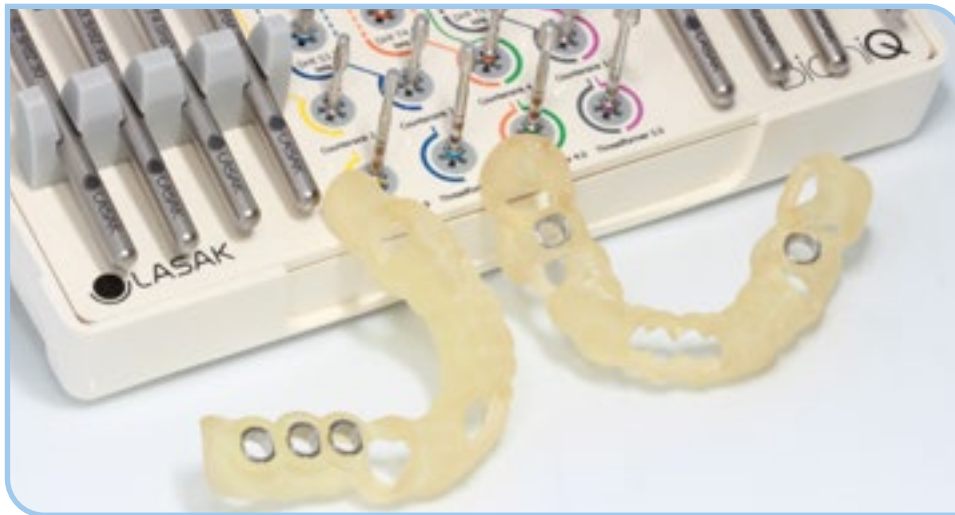
2 A 3D-printed tooth-supported surgical template was designed. The [BioniQ instrument set for guided surgery](#) was used for implant placement.

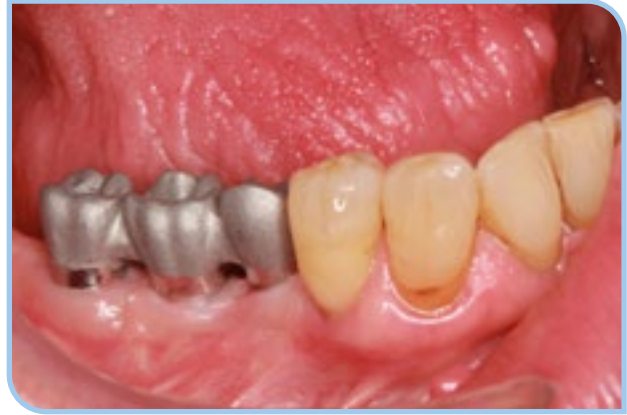
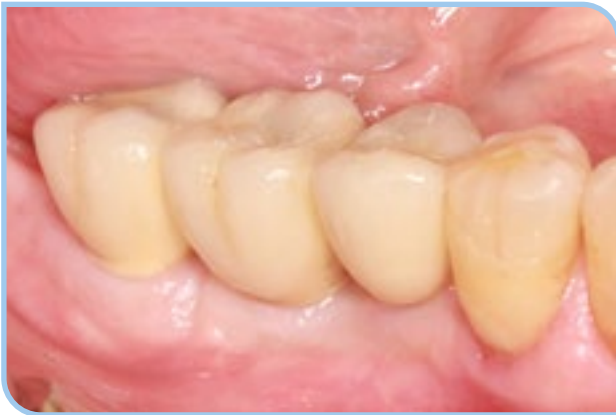
9 The final prosthesis was screwed into the patient's mouth. The patient's expectations of a functional and esthetic result that is stable and sustainable in the long term were met.

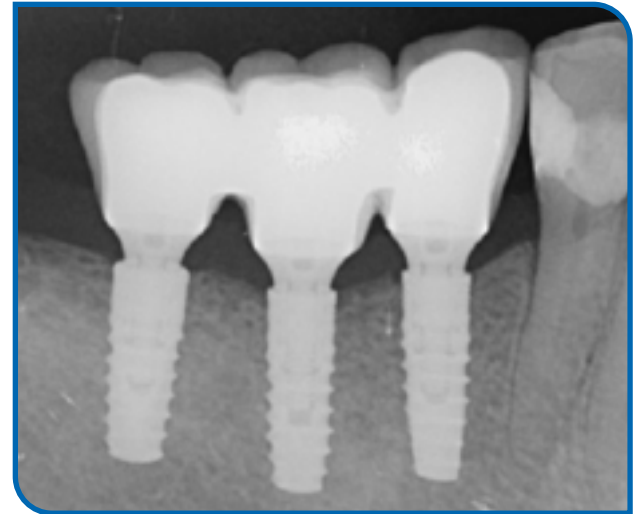
10 The X-ray check after fitting the final restoration.

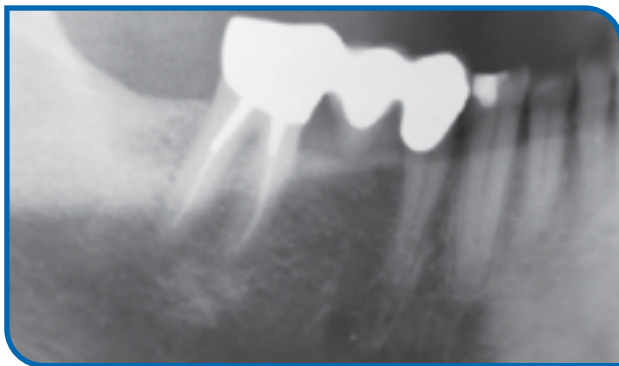
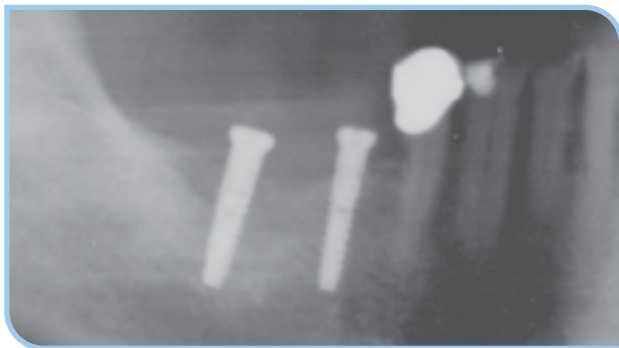
3 The implants were inserted with primary stability and with the machined surface up to bone level. The X-ray check confirms that the [BioniQ Plus implants](#) inserted are of sufficient length.

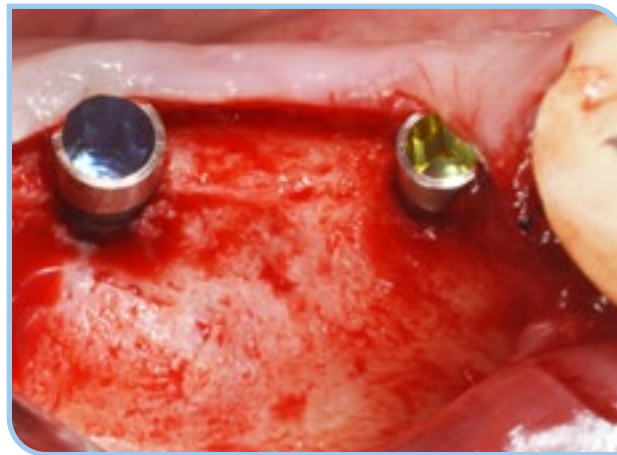
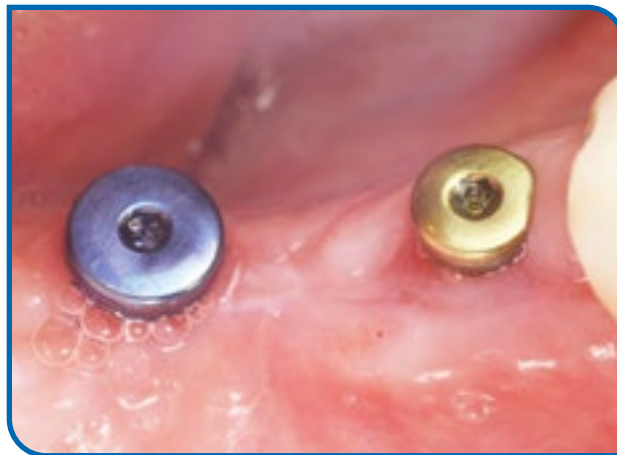
4 During open healing, cleaning checks were carried out with instructions to also clean the cover screws using special brushes to ensure an inflammation-free peri-implant gingiva.

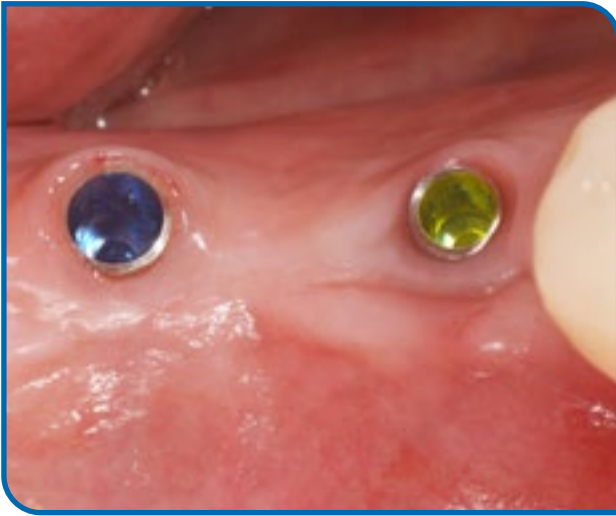
6 In the course of the treatment, the defective crown 44 was also redesigned. The implant fit was verified with an implant control splint to be on the safe side due to the very slight distortion that can never be ruled out when taking the impression.

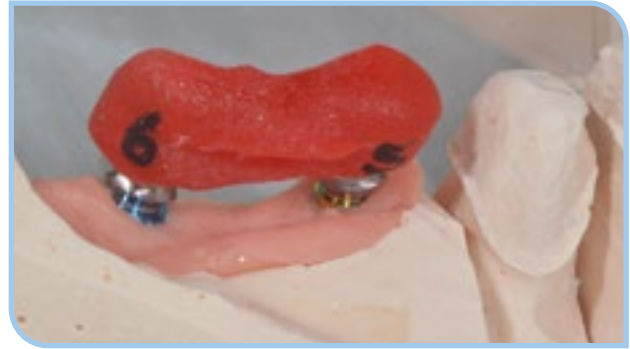
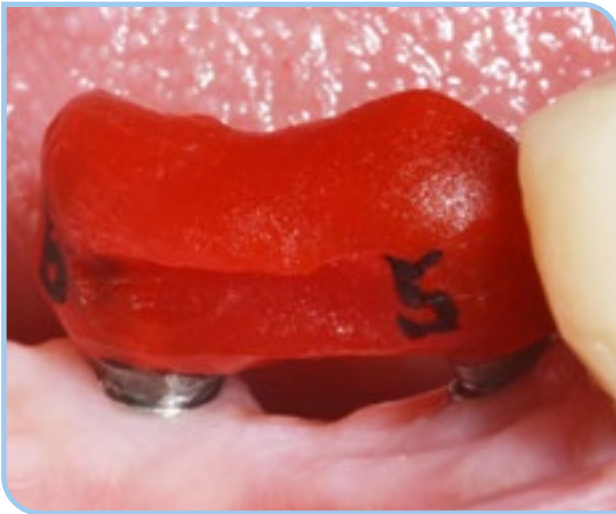
7 Intraorally, the splint can be fitted tightly but without tension.

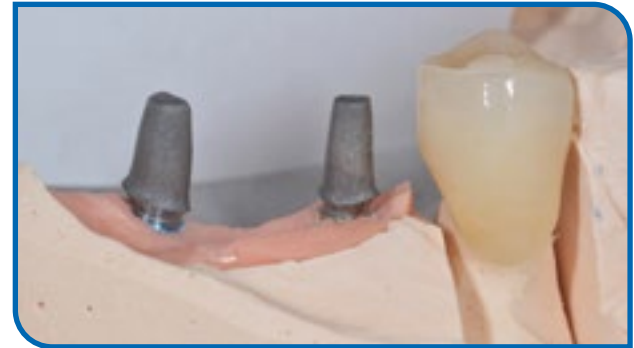
8 If possible, all implant prosthetics should be screw-retained to have quick "service access" in the event of bruxism-related screw loosening, for example. The master dental laboratory sandblasted the tried-in abutments.

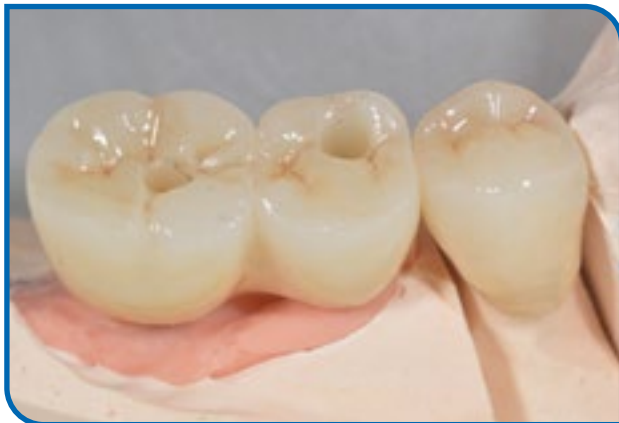
10 After the two abutments were tightened and filled over the screws, the ZrO₂ block was bonded intraorally and the openings were then sealed with plastic material.

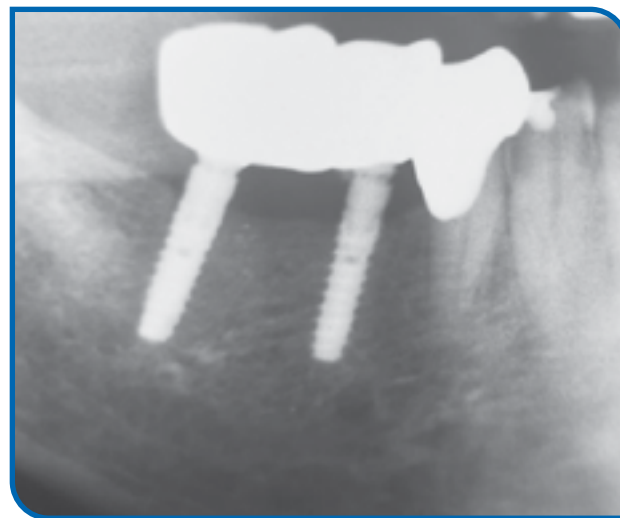
12 The X-ray 14 months later shows a stable peri-implant bone level, which may have increased distally to the 2.9 implant.

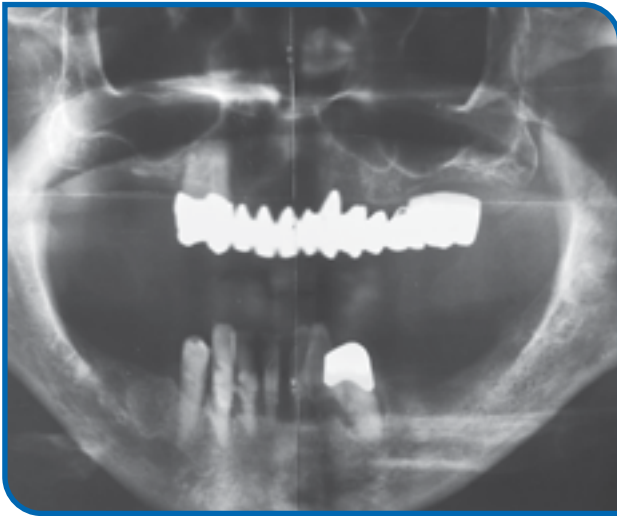
2 Following atraumatic extraction, alveolar curettage, and suturing, two provisional prostheses were inserted. Based on the 3D imaging data, [BioniQ implants](#) with a diameter of 2.9 mm were planned for the maxilla.

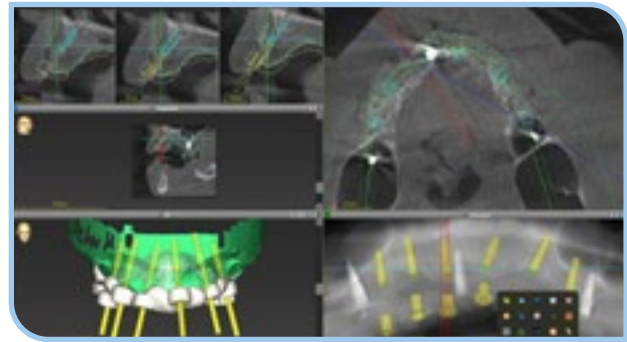
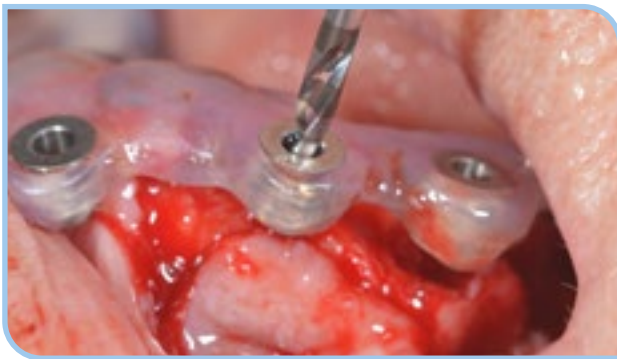
3 The highly atrophic hard tissue did not allow fixation of a surgical template with guided fixation pins and the limited mouth opening restricted the use of a fully guided implant placement technique in the posterior region. Basic [pilot guided drilling](#) was performed.

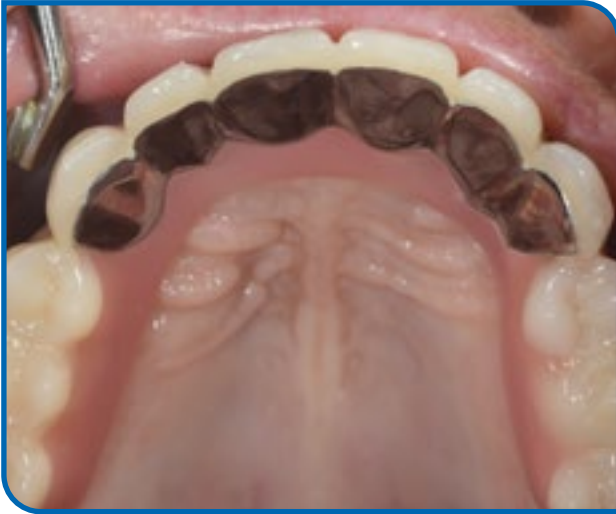
10 In the mandible, the anatomically shift of four implants to the anterior region required a bar-supported prosthesis, ensuring easy cleaning and long-term retention by preventing friction loss.

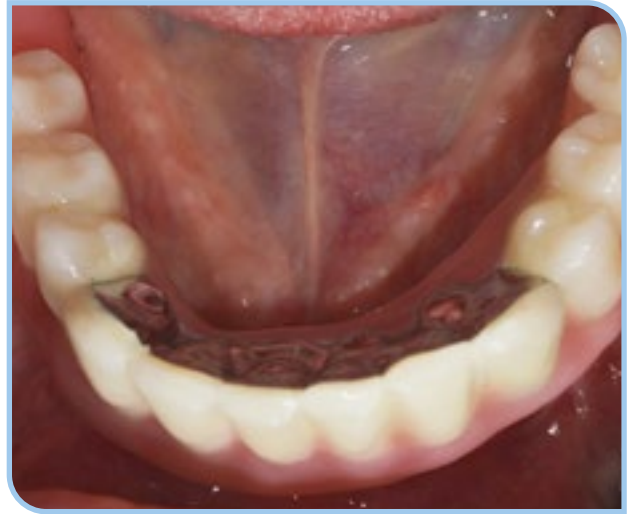
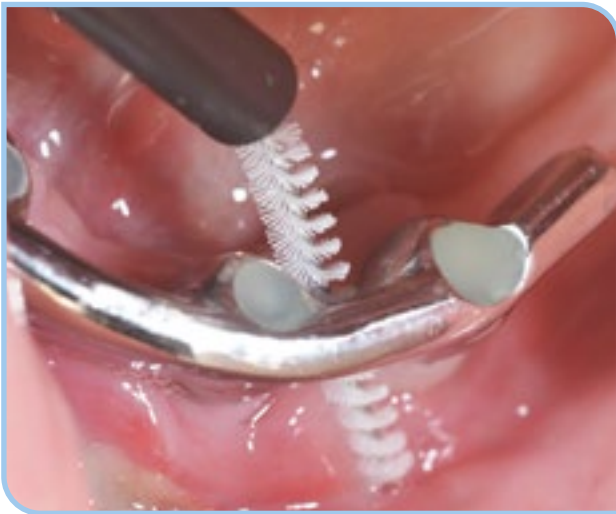
11 The final bar framework was designed for optimal hygiene maintenance.

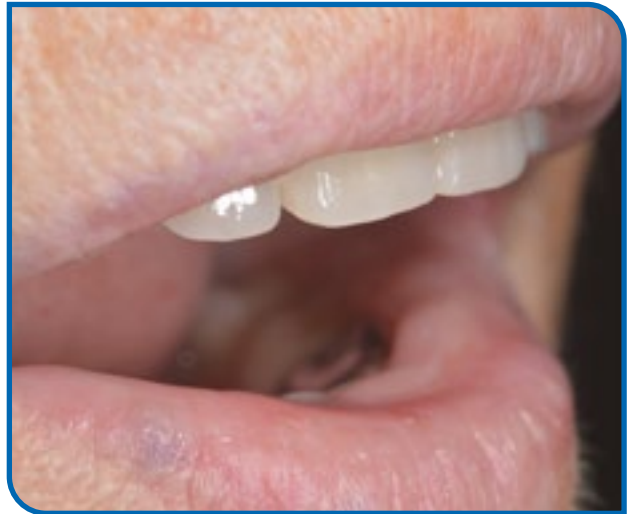
12 Lateral profile of the patient with final prosthetic restoration after completion of the treatment.

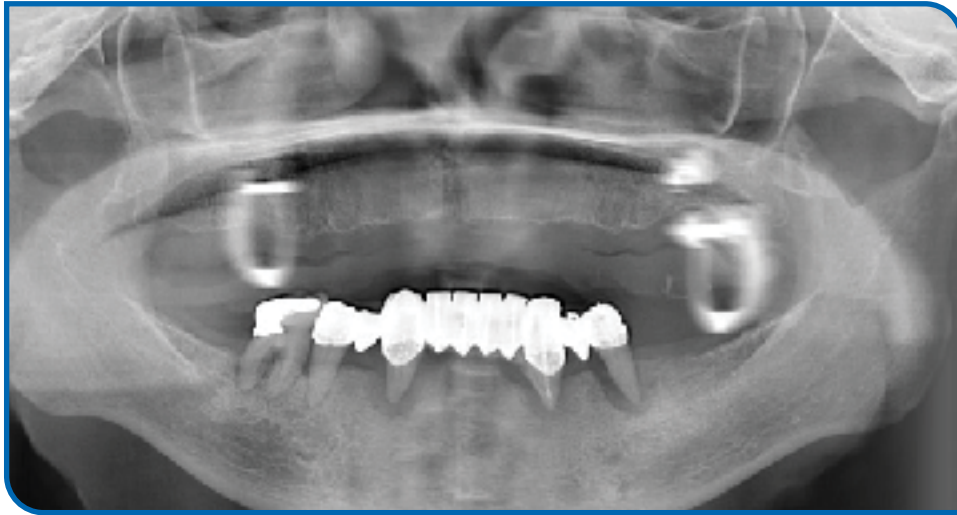
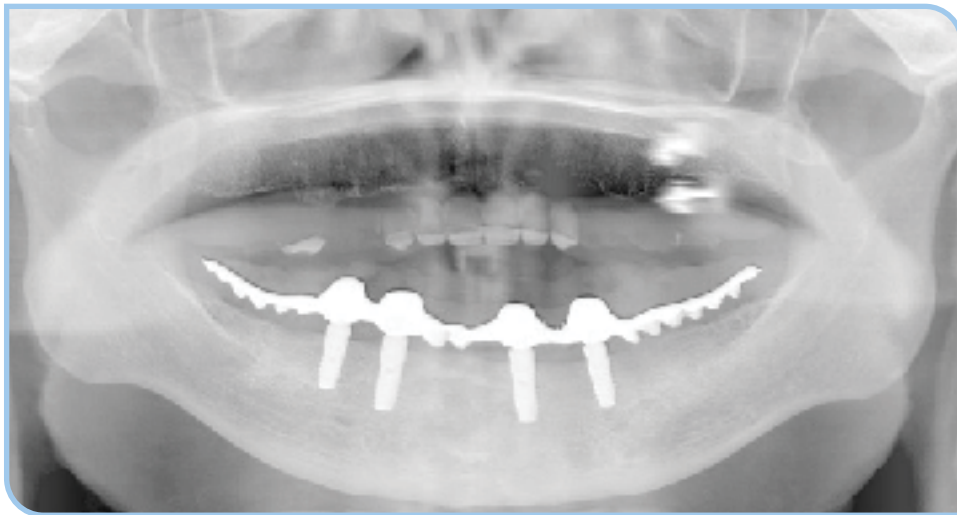
2 Three months after the extraction, four implants were placed in the mandible. [BioniQ Plus implants](#), with a machined neck section of Ø 4 mm and lengths of 10 and 12 mm, were inserted at the soft tissue level. Due to the bone volume, they were inserted in regions 45, 43, 32 and 34. The prosthesis was used as a surgical template.

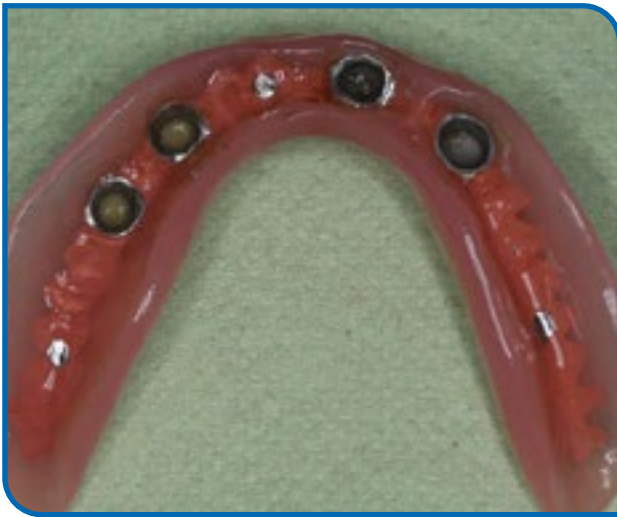
4 Telescope crowns on implants in the mandible.

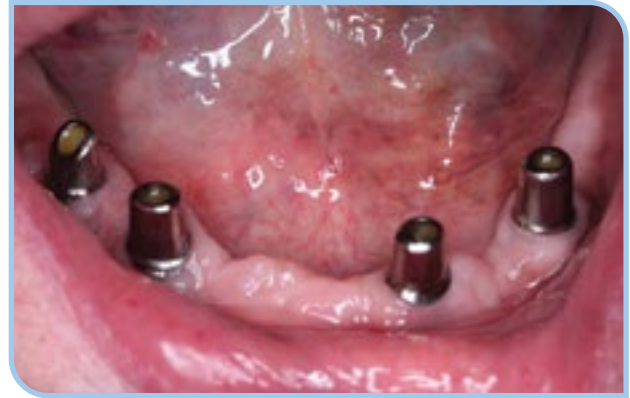
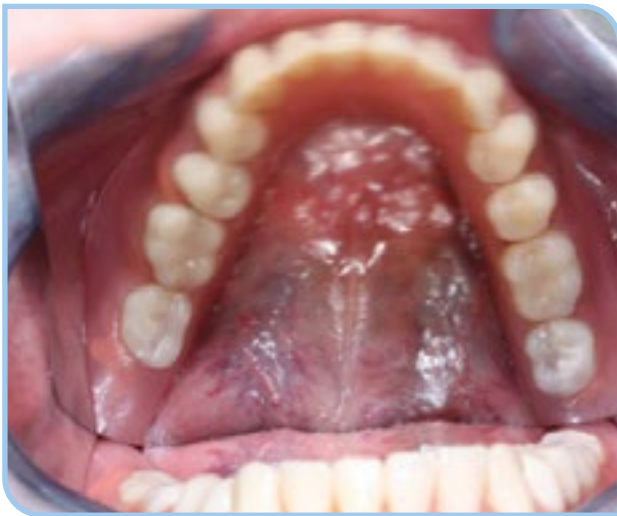
5 The patient found the final treatment satisfactory. At the recall after one year, everything was fine. The patient also wished to be treated with a fixed restoration in the upper jaw.

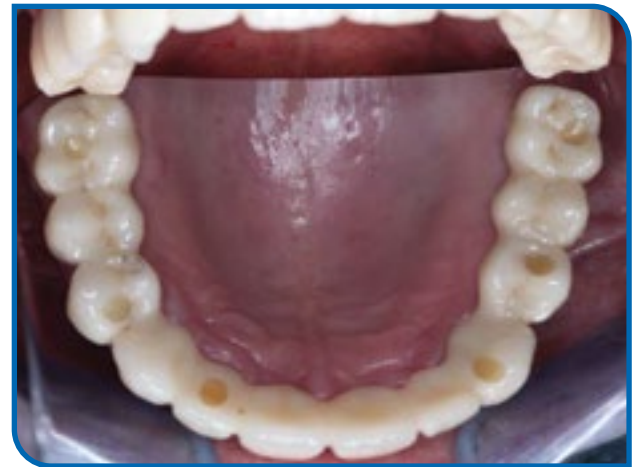
6 In the maxilla 6 [BioniQ implants](#) were placed at the bone level; the anterior tooth area Ø 4 mm, with lengths of 12 and 14 mm, and the molar tooth area Ø 5 mm, with a length of 10 mm. After the healing phase, the patient was treated with a fixed, milled ZrO₂ bridge.

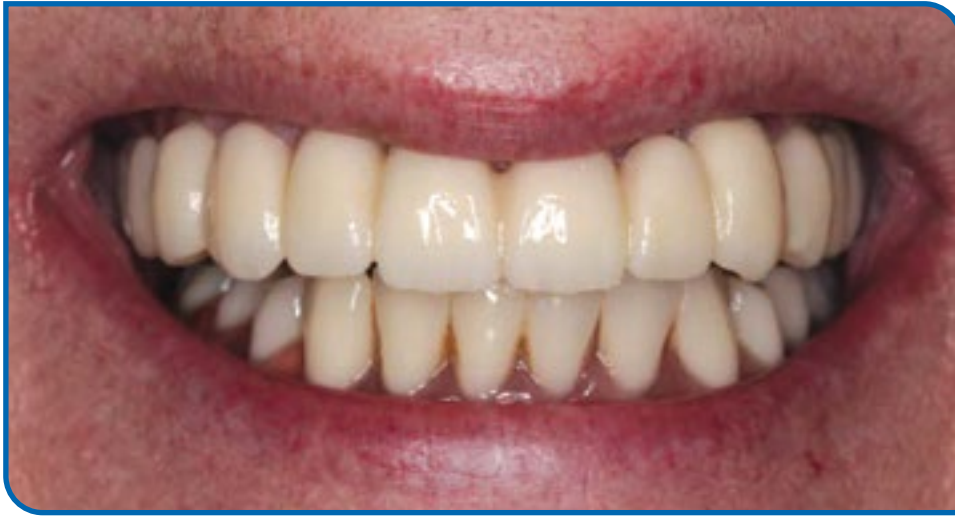
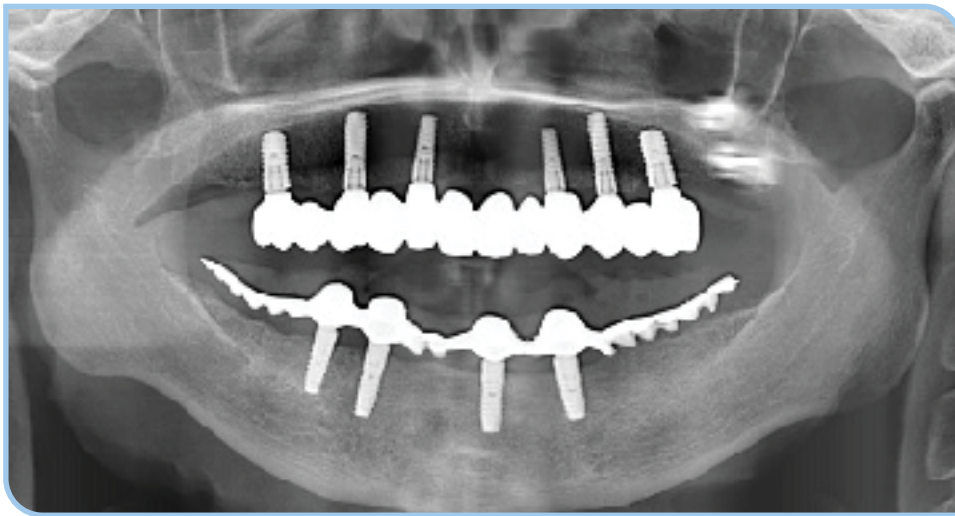
8 The follow-up X-ray also showed the stability of the alveolar bone around the [implants](#). The patient is now three years post-treatment with a stable result.

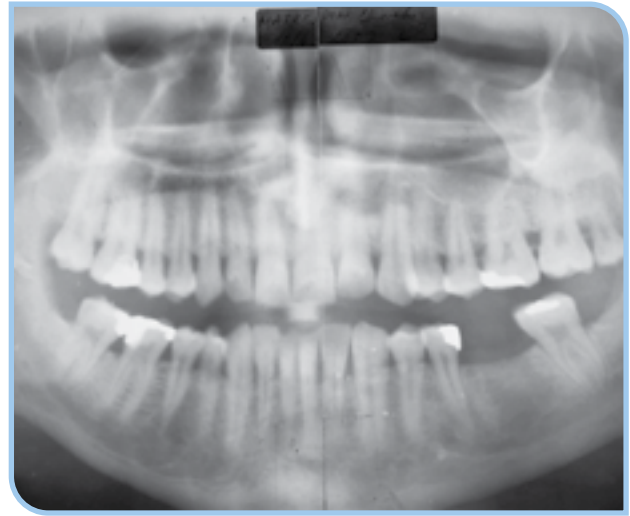
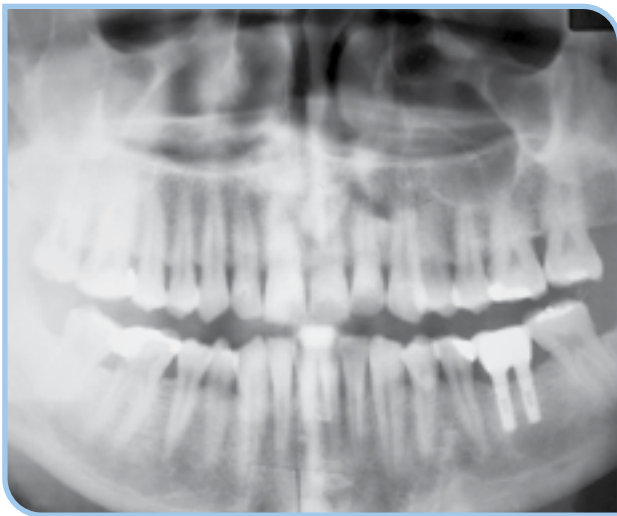
3 At the 10-year recall in April 2013, the prosthetic restoration was still fully functional, and the peri-implant tissues remained healthy.

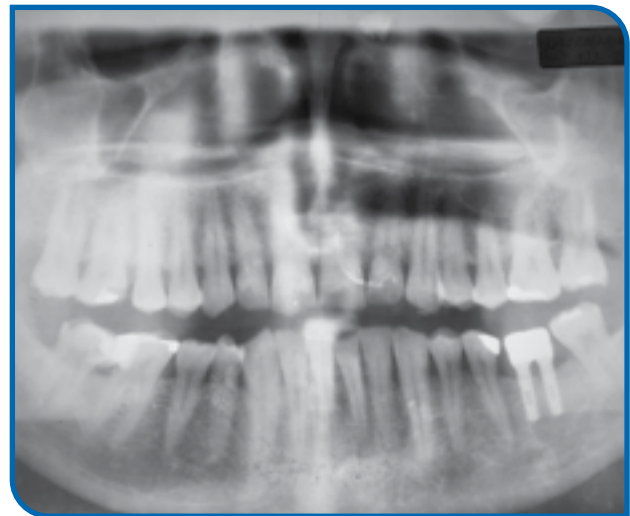
4 At the 21-year recall in March 2024, a follow-up X-ray confirmed implant stability with an unremarkable clinical presentation. No peri-implant bone resorption was detected over the entire period (0 mm).

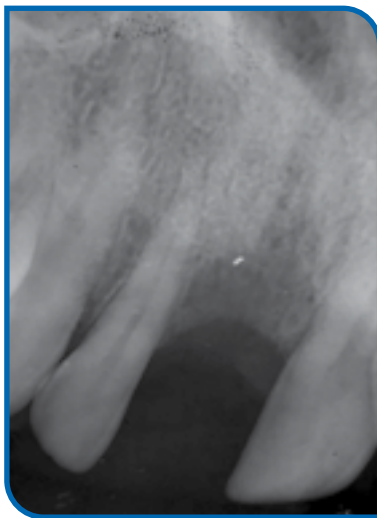
2 An implant with a diameter of 3.7 mm and a length of 12 mm was inserted in November 2001. A follow-up X-ray was taken 5 months after implantation.

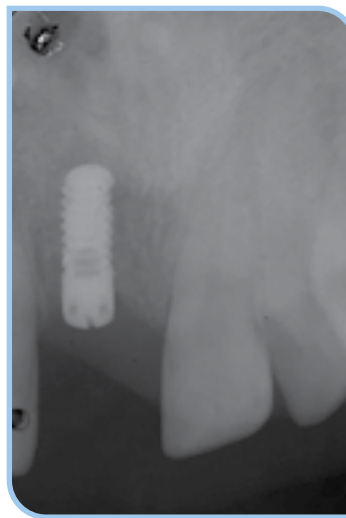
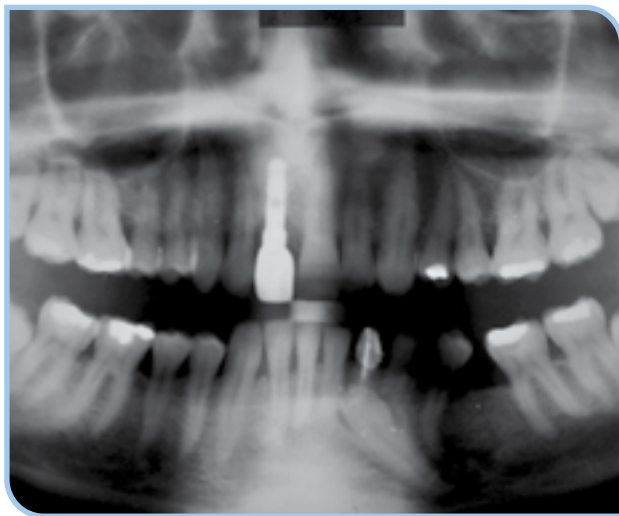
3 After the implant healed, a metal-ceramic crown was fitted in June 2002. No objective or subjective changes were noted during regular recalls. Follow-up X-ray was taken in January 2003.

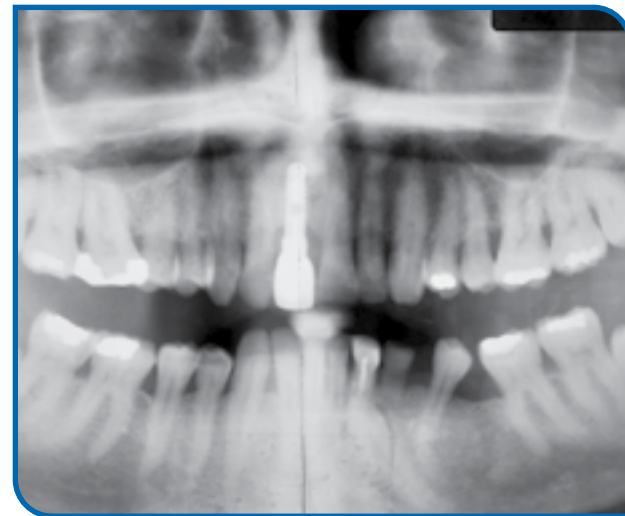
4 The most recent X-ray from November 2024. The implant has been functional for 23 years. Despite significant bruxism, the original dental restoration remains both functional and esthetically intact.
